Manhole Inspection Summary

Manhole # S35G__061MH

Insp Date: **10/31/08 2:32 PM**

Location Address: **side 101 e baltimore st**

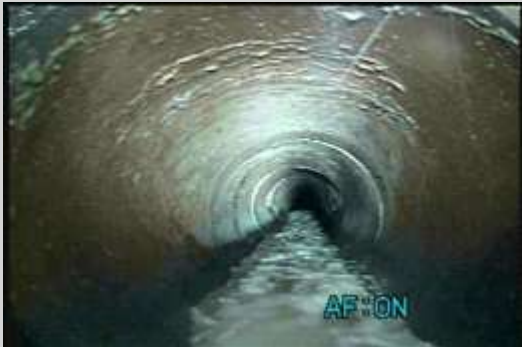
12 O'Clock Outflow

12 in. Circular Gravity Sewer
Pipe Out @ 12 O'Clock

Pipe Material: **Clay** ☐ Pipe Lined

Invert Depth: **24.00** (ft.) Flow Characteristics: **Fast**

Deposits: ☒ None ☐ Mud ☐ Sludge ☐ Debris ☐ Grease

Infiltration: **None** Pipe Seal Cond: **Unknown**

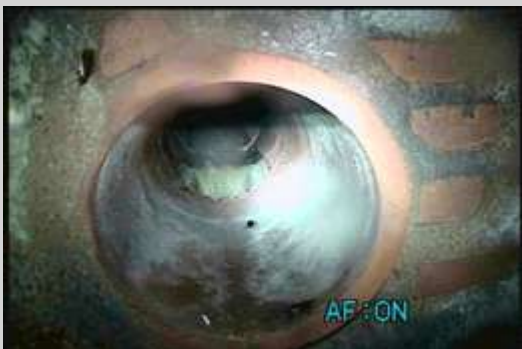
3 O'Clock Inflow

12 in. Circular Gravity Sewer
Pipe In @ 3 O'Clock

Drop In @ 3 O'Clock

Pipe Material: **Clay** ☐ Pipe Lined

Invert Depth: **22.92** (ft.) Flow Characteristics: **Fast**

Infiltration: **None** Pipe Seal Cond: **Unknown**

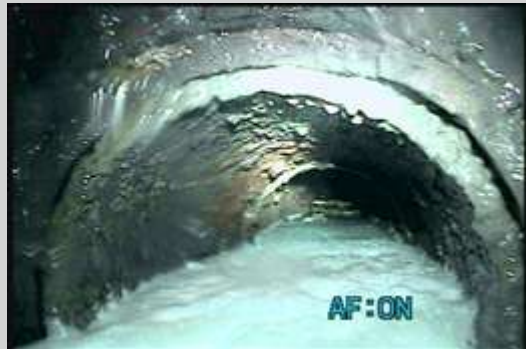
5 O'Clock Inflow

12 in. Circular Gravity Sewer
Pipe In @ 5 O'Clock

Pipe Material: **Clay** ☐ Pipe Lined

Infiltration: **None**
